LETTER REPORT
FOR
BOWERS BATTERY SITE
NEW PHILADELPHIA, TUSCARAWAS COUNTY, OHIO
TDD: S05-0010-022
PAN: 0C2201SIXX
START DOCUMENT CONTROL NUMBER: START-05-23-050132

Re: Bowers Battery Site
New Philadelphia, Tuscarawas County, Ohio
TDD: S05-0010-022
PAN: 0C2201SIXX

Attachment D
Photodocumentation

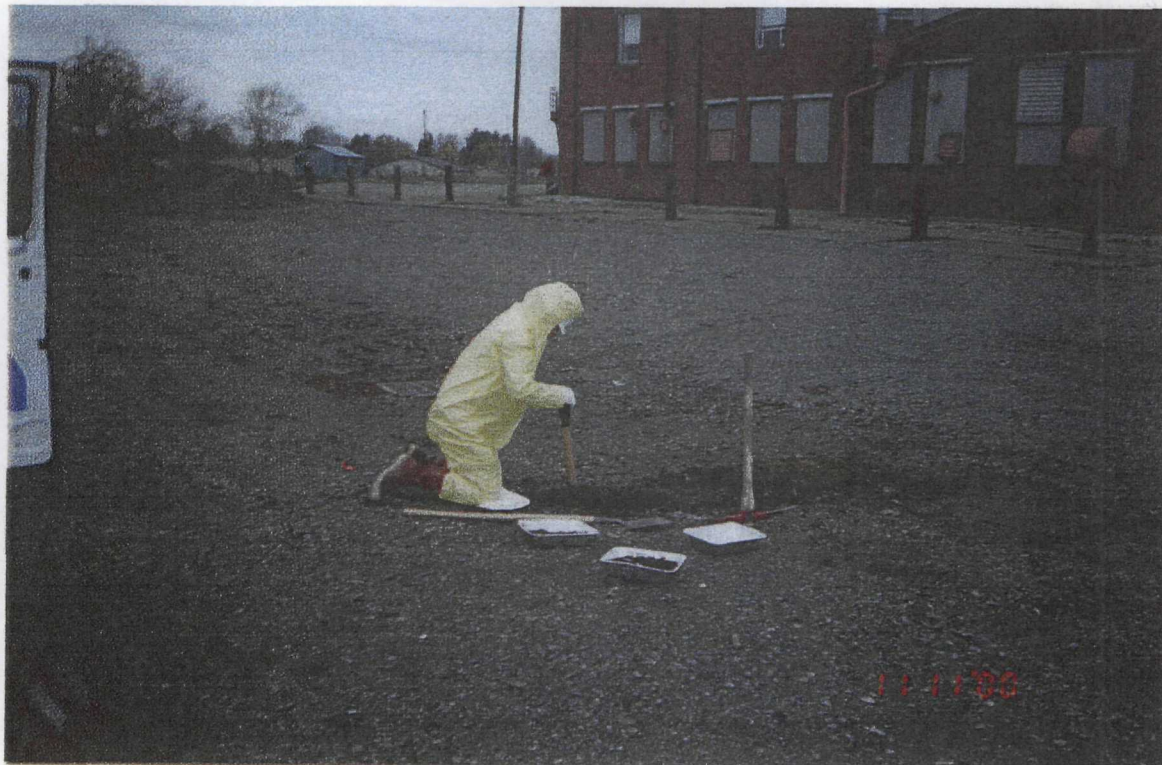
SITE: Bowers Battery **TDD:** S05-0010-022 **PAN:** 0C2201SIXX **PHOTO:** 24
DATE: November 11, 2000 **DIRECTION:** North **PHOTOGRAPHER:** D. Pearce
SUBJECT: View of START member collecting soil from sampling location BB-N-01B at the north transect which runs from BB-PL-26 to the corner of the brick building in the background. This transect is approximately 100 feet in length.
